Upper Arkansas Watershed Partnership:

Stream Corridor Hazard and Floodplain Connectivity Assessment

Opportunities for Fluvial Hazard Mitigation and Improved Stream Corridor Function

December, 2022

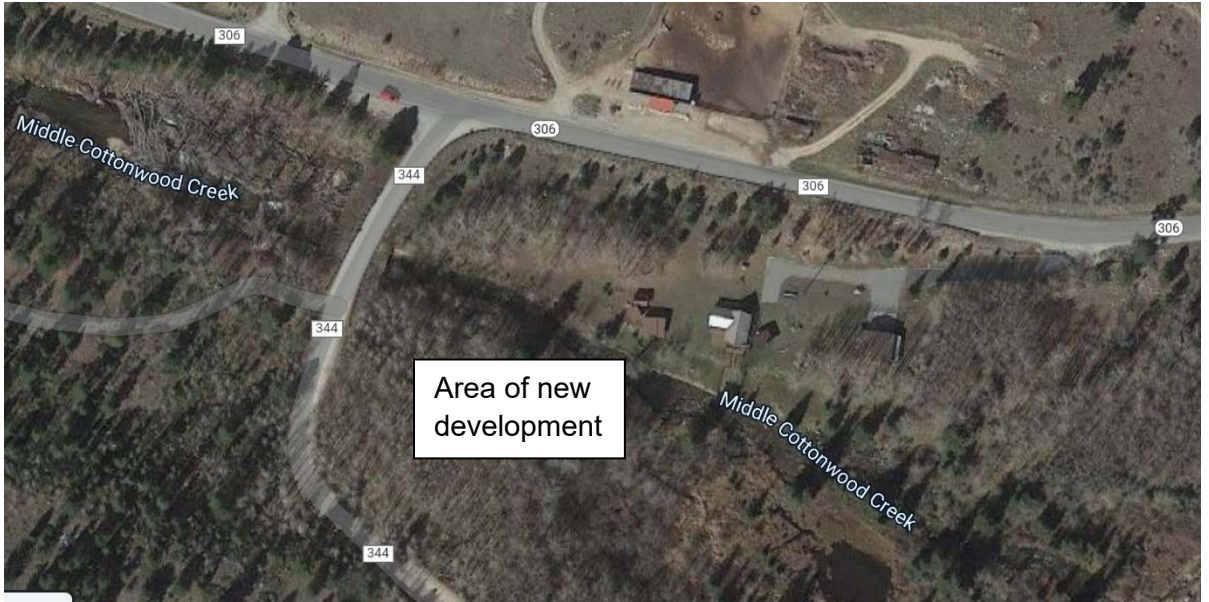
Cottonwood R07

ID	Location		
CW7	Vicinity of CR 344 crossing over Cottonwood Creek.		
	Justification		
	Crossing is undersized relative to the potential sediment and debris coming from the watershed (further exacerbated by the dam-effect of the roadway as it bisects the Active Stream Corridor). Development on d/s side of CR 344 bridge vulnerable if bridge plugs and flanks (large wood loading upstream of structure is excellent habitat, however mobility of this material through the culvert is not guaranteed even though the culvert is better-sized than most found in the County.		
Type	Description	Cost	Partners
Mitigate Existing Hazards	Further engineering, sediment, and debris analysis/study to consider existing structure limitations, risks, and consequences as well as whether options for improvement exist.	\$	County, Private landowner(s)

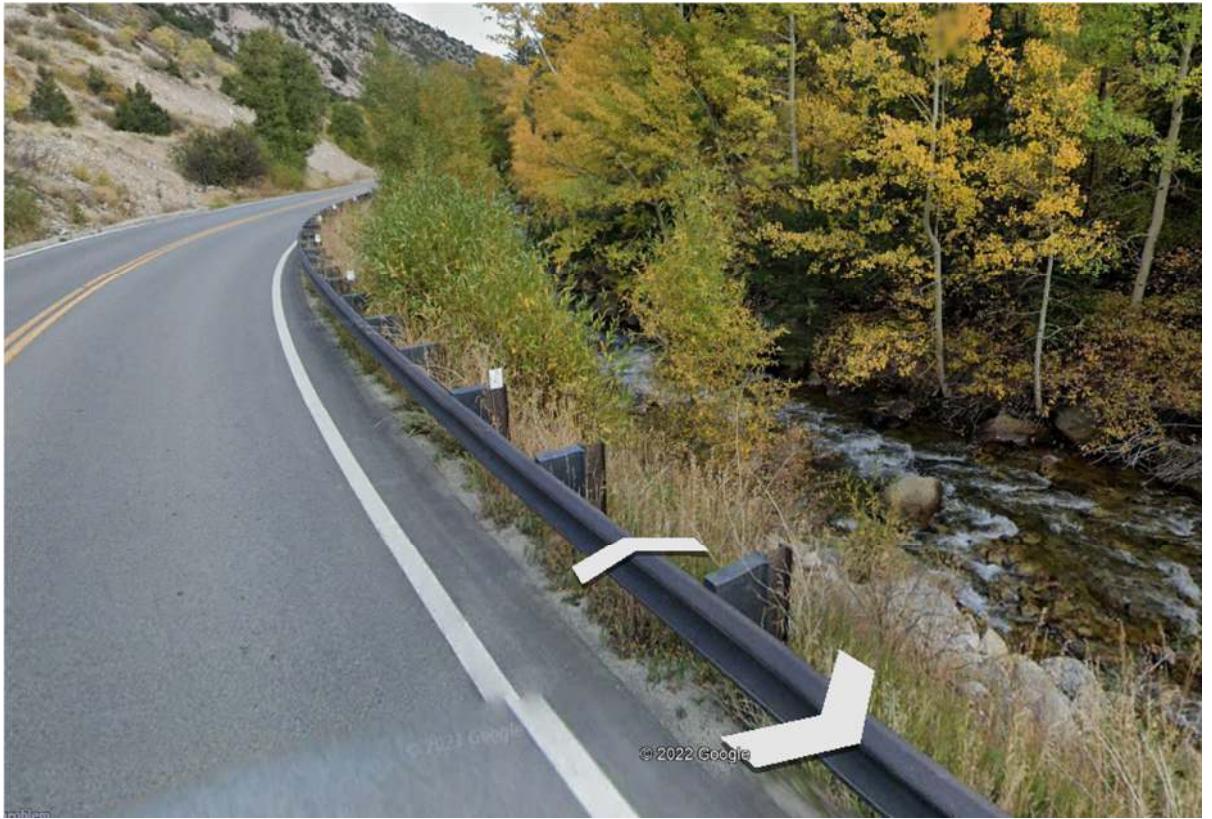
Cottonwood R06

ID	Location		
CW6	Where CR 306 contacts that channel and or is placed on fill in the Active Stream Corridor.		
	Justification		
	Highway washout is all but assured in a significant flow event due to the confined corridor, high shear stresses and stream power, and debris loads both from upstream and adjacent hillslopes. There are also at least three drainages, and several possible debris flow paths, from the north that could block the highway and creek.		
Type	Description	Cost	Partners
Mitigate Existing Hazards	County should be prepared for having this roadway become impassable following a flood event. Ensure this topic is discussed in local hazard and emergency planning.	\$	County

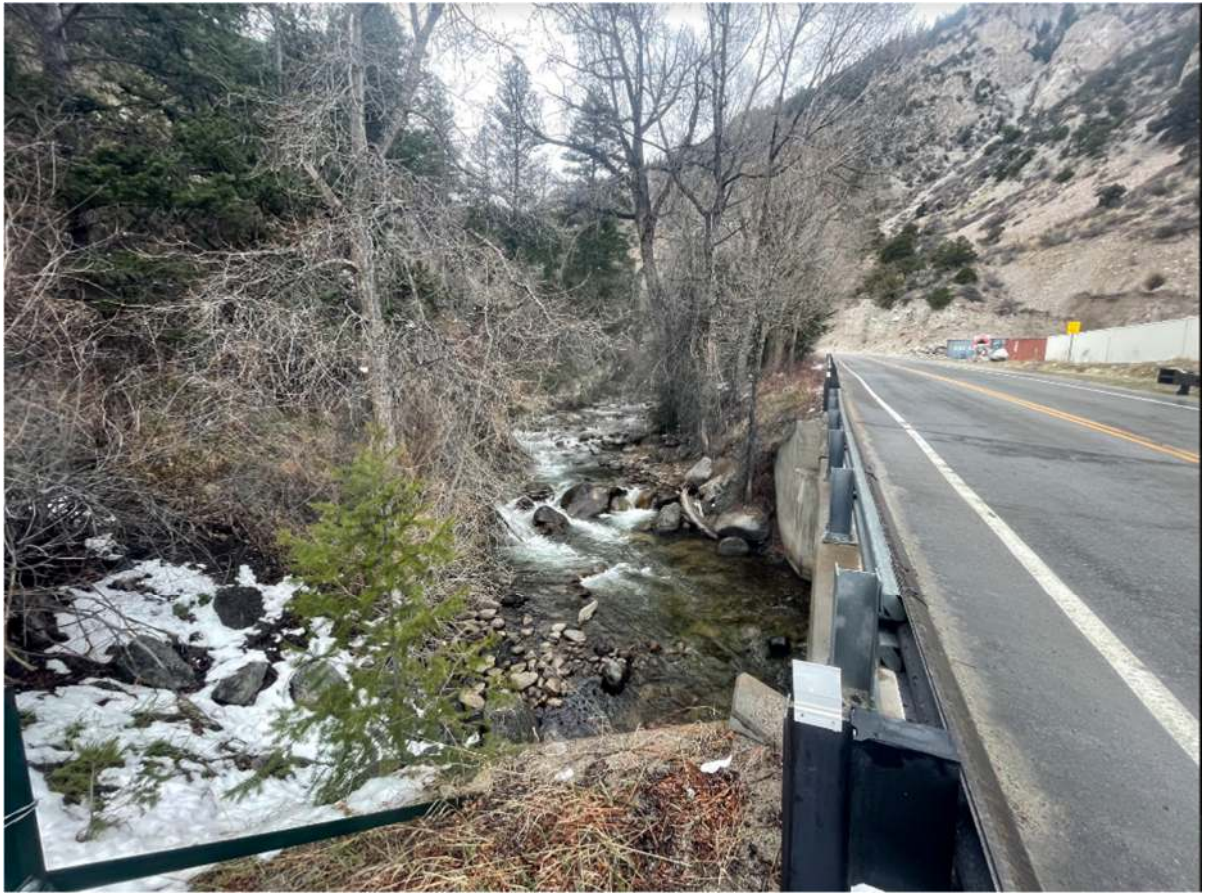
Cottonwood R05

ID	Location		
CW5a	CR306 crossing u/s of Cottonwood Hot Springs		
	Justification		
	Bridge washout/flanking and roadway damage of CR306 and crossing likely during flood event. County crossing forces the channel into a sharp bend. Plugging of the bridge may cause the channel to avulse as it flows down valley eroding a new channel out of the roadway before re-entering the existing channel further downstream toward the hot springs.		
Type	Description	Cost	Partners
Infrastructure Retrofits and Upgrades	Further engineering, sediment, and debris analysis/study to consider existing structure limitations, risks, and consequences as well as whether options for improvement exist.	\$\$	County

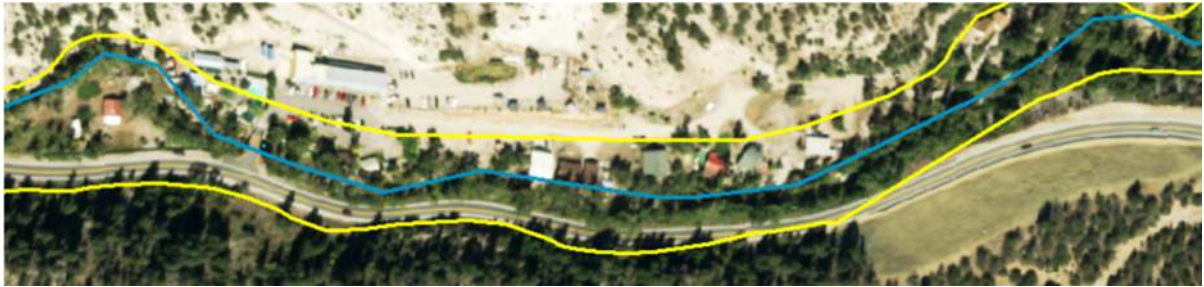
Cottonwood R05 (cont.)

ID	Location		
CW5b	Vicinity of Cottonwood Hot Springs - commercial and residential development.		
	Justification		
	Commercial business and private property damage possible.		
Type	Description	Cost	Partners
Mitigate Existing Hazards	Evacuation plans for moving staff, customers, and residents out of the valley bottom during a flood may be the only way to prepare for the existing hazard.	\$	Private

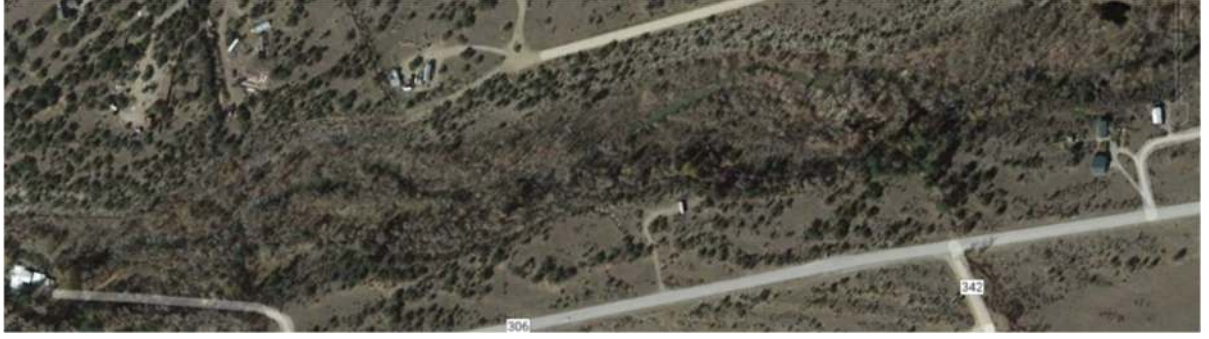
Cottonwood R04

ID	Location		
CW4a	Vicinity of Michigan Ditch diversion to CR 340 crossing.		
	Justification		
	Reach appears to have good riparian health and large wood accumulation. It has, thus far, been spared from development. This is an important corridor to protect as it has the potential to capture and accumulate large amounts of sediment and debris; doing so may provide protection to downstream residents and infrastructure.		
Type	Description	Cost	Partners
Corridor Rehabilitation, Reconnection, and/or Restoration	Work with landowners to assess stream corridor connectivity and riparian function. Specific management recommendations beyond these are limited due to access which prevented our ability to evaluate the current condition of the reach beyond what was visible from public roads.	\$	NGO, Private
Land and Water Protection

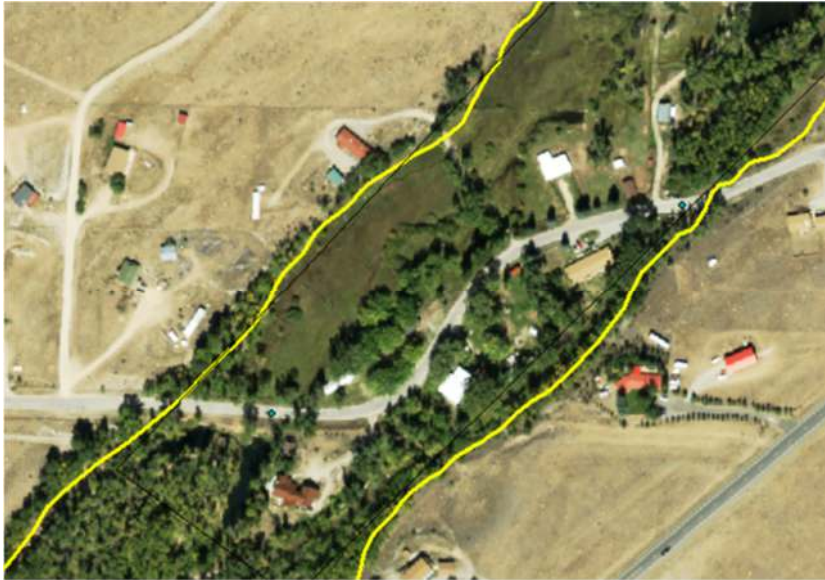
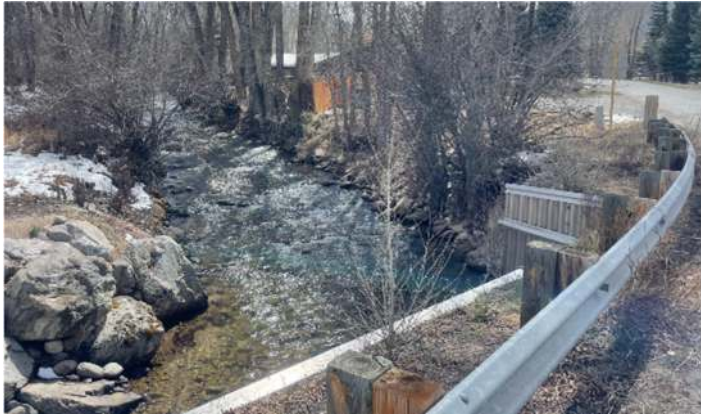
Cottonwood R04 (cont.)

ID	Location		
CW4b	Vicinity of CR 340 and CR 338 crossings		
	Justification		
	Development in ASC in the vicinity of both these county road crossings seems particularly vulnerable to flooding due to undersized road crossings and water backing up behind the road prisms.		
Type	Description	Cost	Partners
Mitigate Existing Hazards	A conceptual design is needed to evaluate the avulsion pathway to the north, enhanced crossings, and debris passages concerns specific to this area.	\$\$\$	Private

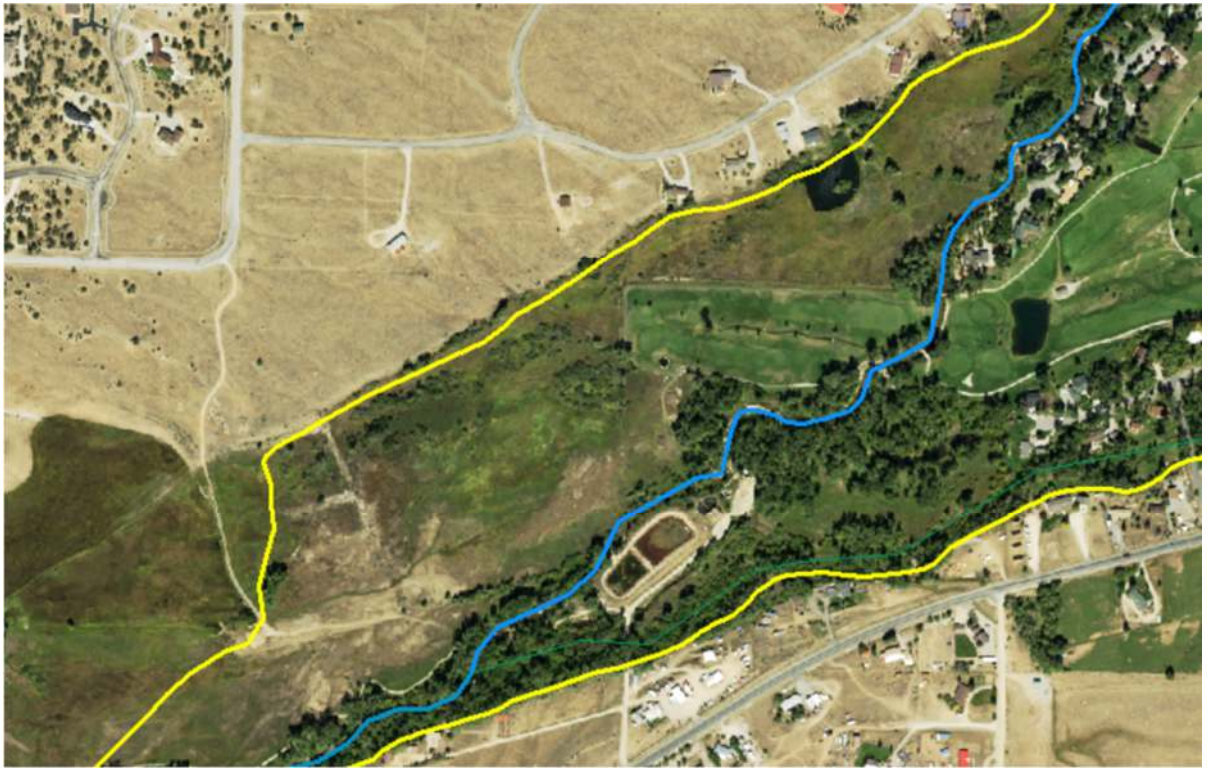
Cottonwood R03

ID	Location		
CW3a	Downstream from CR 361 crossing (generally)		
	Justification		
	The area where geomorphic floodplain width expands dramatically could become a natural deposition area for sediment and debris.		
Type	Description	Cost	Partners
<p>Corridor Rehabilitation, Reconnection, and/or Restoration</p> <p>Land and Water Protection</p>	<p>Maintain field in agricultural use. Investigate opportunities for stream corridor restoration.</p>

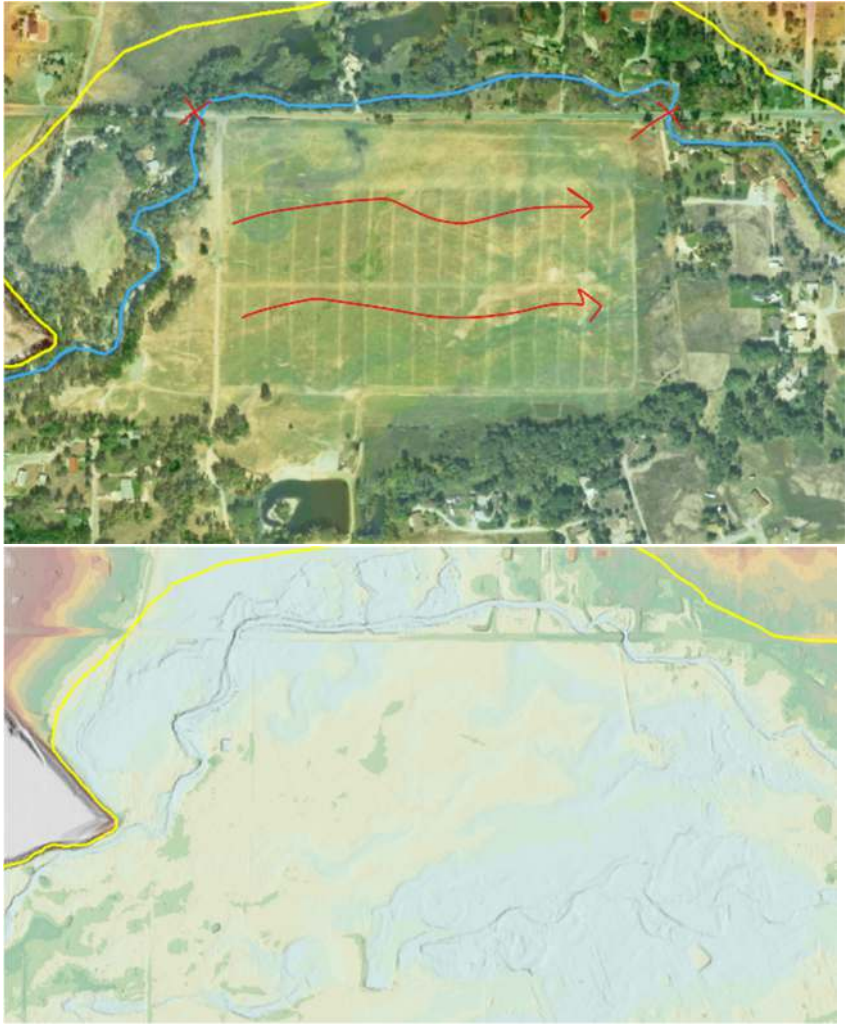
Cottonwood R03 (cont.)

ID	Location		
CW3b	CR 350 crossings		
	Justification		
	Undersized road crossings at sharp angles combined with the historic lengthening of stream channel (reducing the slope) make an avulsion likely here.		
Type	Description	Cost	Partners
Land and Water Protection	Maintain field in agricultural use.	\$-\$\$	Private, NGO

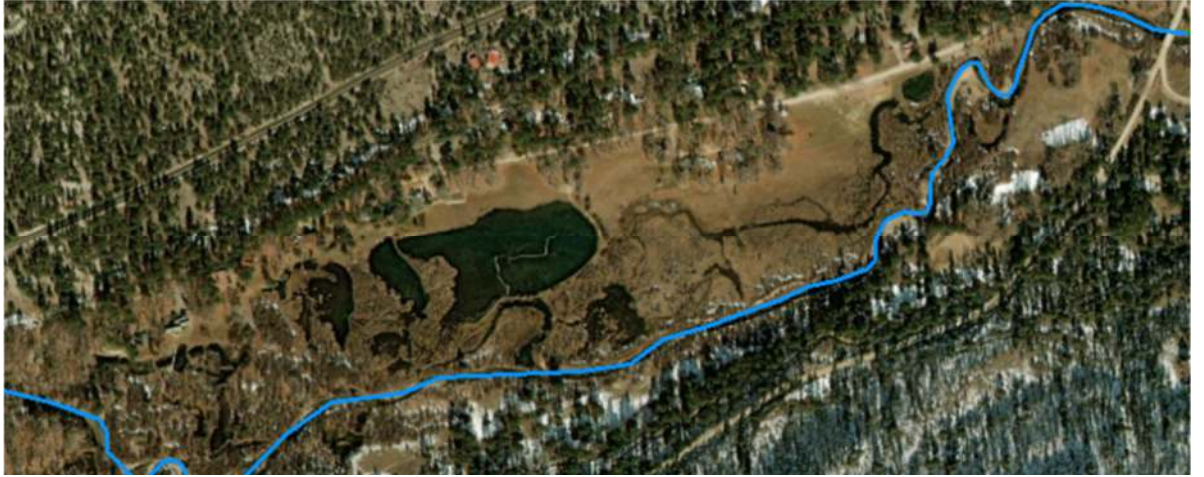
Chalk R05

ID	Location		
CK5	Upstream of CR 290 crossing of Chalk Creek. Vicinity of Bunny Lane.		
	Justification		
	A unique natural depositional pockets that exists on Chalk Creek downstream of Alpine Lake. This is an expansive floodplain with good energy dissipation potential coming from the ponds and vegetation. Most of the land is in public trust with Colorado Parks and Wildlife.		
Type	Description	Cost	Partners
Corridor Rehabilitation, Reconnection, and/or Restoration	Meet with CPW to discuss challenges and opportunities of stream corridor health (there is private landowner development and clearing of vegetation in the vicinity of the stream corridor) and ensure long-term protection for this reach. Maybe an opportunity to enhance this site further with a low-tech restoration project.	\$-\$\$	NGO, Private
Land and Water Protection

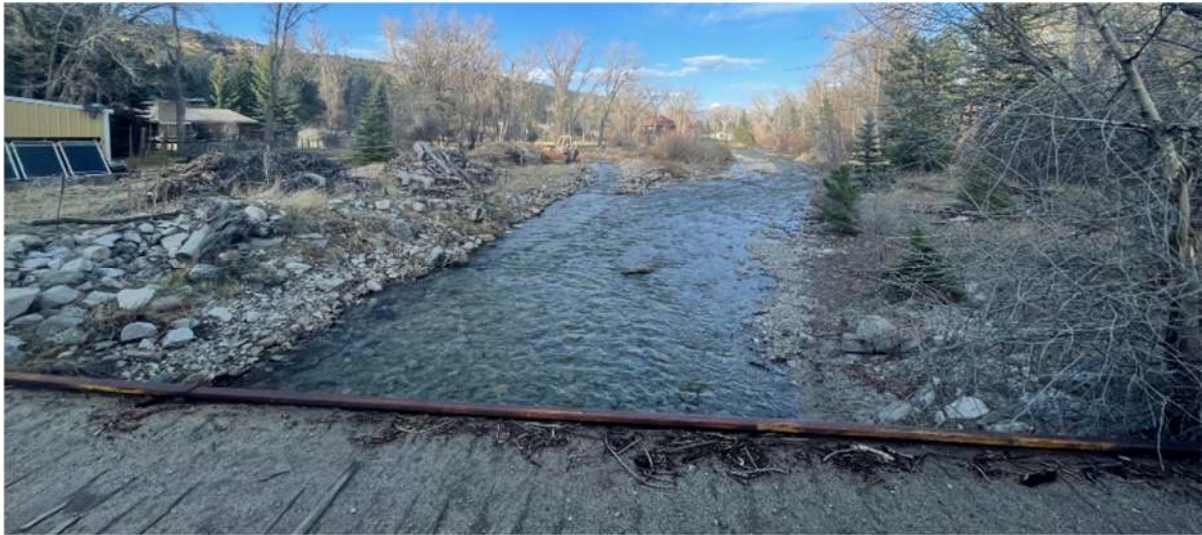
Chalk R04

ID	Location		
CK4a	TreeHouse Hot Springs vicinity - unnamed County Road.		
	Justification		
	Low clearance bridge has the potential to be blocked given the sediment and debris supply upstream from the Chalk Cliffs. Existing infrastructure located within the Active Stream Corridor is vulnerable to fluvial hazards.		
Type	Description	Cost	Partners
Mitigate Existing Hazards	Concept designs that address hazards, bank erosion, and whether debris accumulation issues can be mitigated. Evacuation planning and awareness is highly recommended.	-\$-\$-\$-\$	Private, County

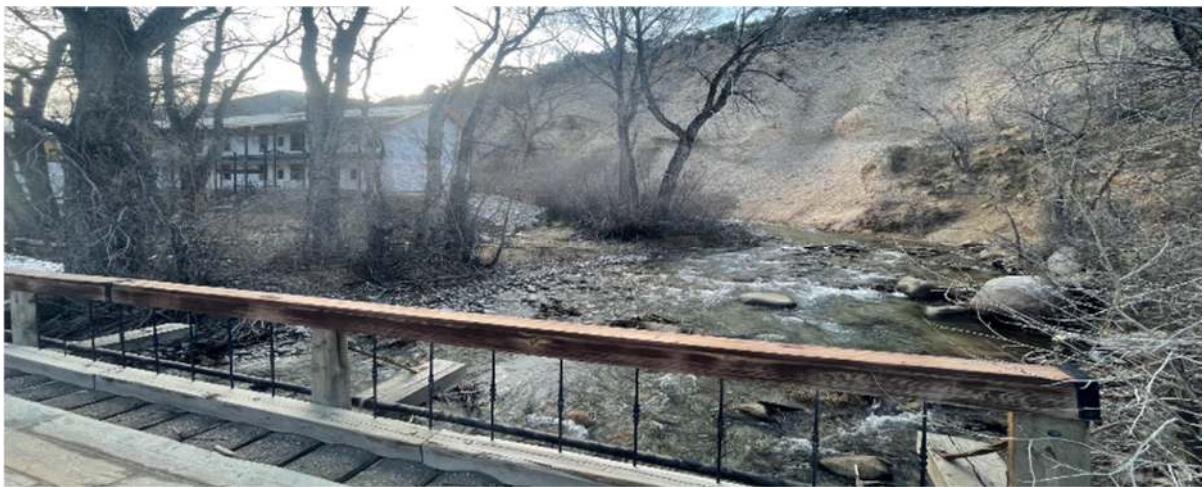
Chalk R04 (cont.)

ID	Location		
CK4b	Vicinity of Mount Princeton Hot Springs.		
	Justification		
	New development at Mt Princeton Hot Springs in the 1) Active Stream Corridor and 2) below erodible hillslopes, and 3) adjacent to small bridges is at risk from compounding and complex natural processes.		
Type	Description	Cost	Partners
Mitigate Existing Hazards	Concept designs that address depositional hazards, bank erosion, and debris accumulation issues. Evacuation planning and awareness, including staff training, is highly recommended.	\$\$	Private, County

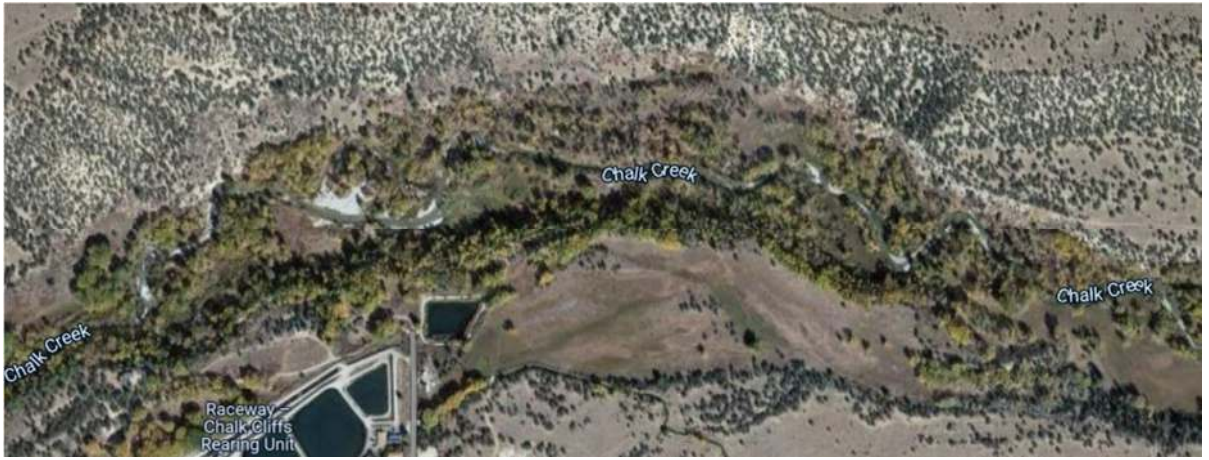
Chalk R03

ID	Location		
CK3	From Princeton Parkway (approximately) to downstream of the fish hatchery.		
	Justification		
	Further study to understand the condition of this reach is needed. Reach may be an area where ecological uplift and stream corridor function can be enhanced for the benefit of watershed health without significant intervention.		
Type	Description	Cost	Partners
Corridor Rehabilitation, Reconnection, and/or Restoration	Meet with landowners to discuss challenges and opportunities of stream corridor health and protection in this reach. Could be a candidate for PALS and other low-tech improvements.	\$-\$\$\$	NGO, Private
Land and Water Protection

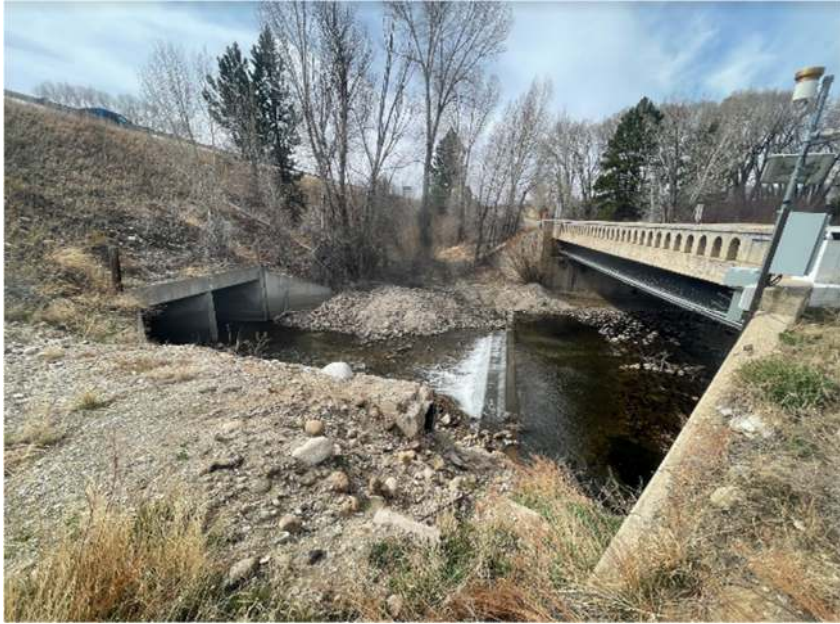
Chalk R02

ID	Location		
CK2a	CR 286 and US 285 crossing vicinity.		
	Justification		
	US 285 bridge has significant impacts on the lower end of the reach. It also appears that there may be a fish passage blockage created by the roadway crossings here.		
Type	Description	Cost	Partners
Infrastructure Retrofits and Upgrades	Conceptual design to address crossing impacts on stream corridor health and hazards. Evacuation planning and awareness consideration for upstream property.	\$-\$\$\$\$	County, CDOT, Private

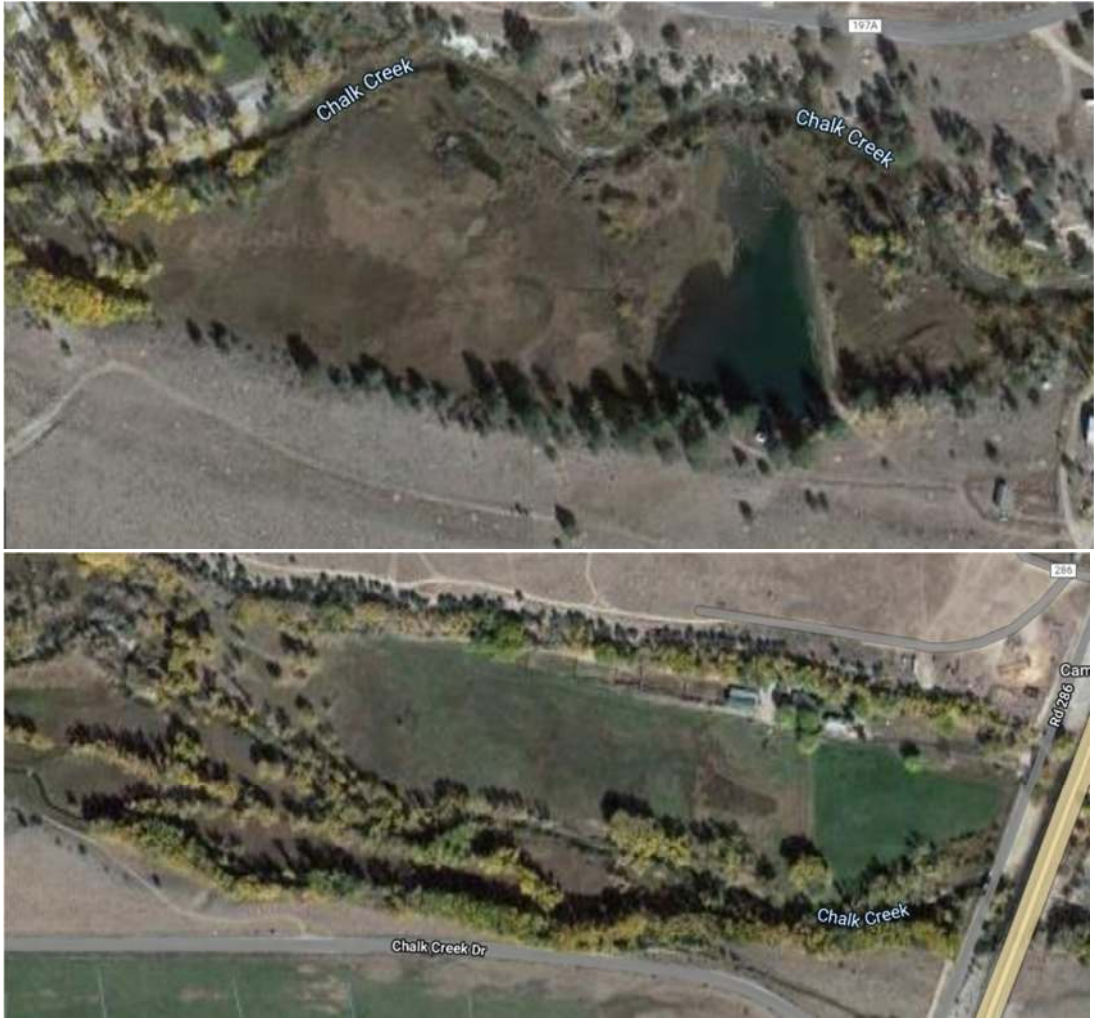
Chalk R02 (cont.)

ID	Location		
CK2b	Upstream and downstream of Highway 285 crossing		
	Justification		
	Undeveloped stream corridors – there appears to be evidence of past beaver ponds downstream of the highway. Upstream, the channel has been straightened for agriculture.		
Type	Description	Cost	Partners
<p>Corridor Rehabilitation, Reconnection, and/or Restoration</p> <p>Land and Water Protection</p>	Investigate landownership and conservation/restoration potential.	\$	NGO, Private

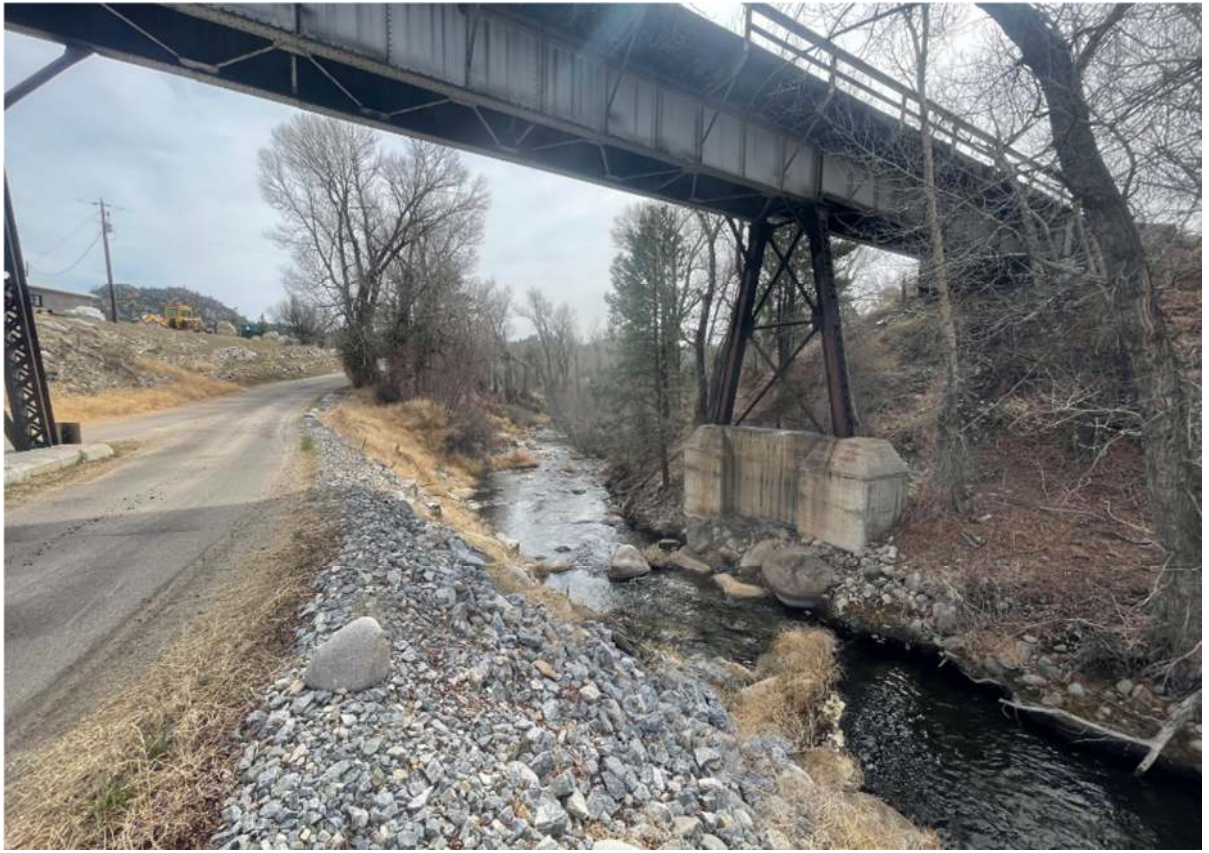
Chalk R01

ID	Location		
CK1	CR197A and Railroad crossing vicinity.		
	Justification		
	The road to the trailer park causes a localized constriction (under the railroad bridge). Increased shear stress and stream power are likely to result in erosion in this reach during a flood as a result of sediment supply disruption from CO 285 crossing upstream.		
Type	Description	Cost	Partners
Infrastructure Retrofits and Upgrades	Relocate roadbed fill to reestablish channel floodplain. Ensure railroad bridge modifications/improvements reduce constrictions of the stream corridor.	\$	County, State, Feds, Union Pacific

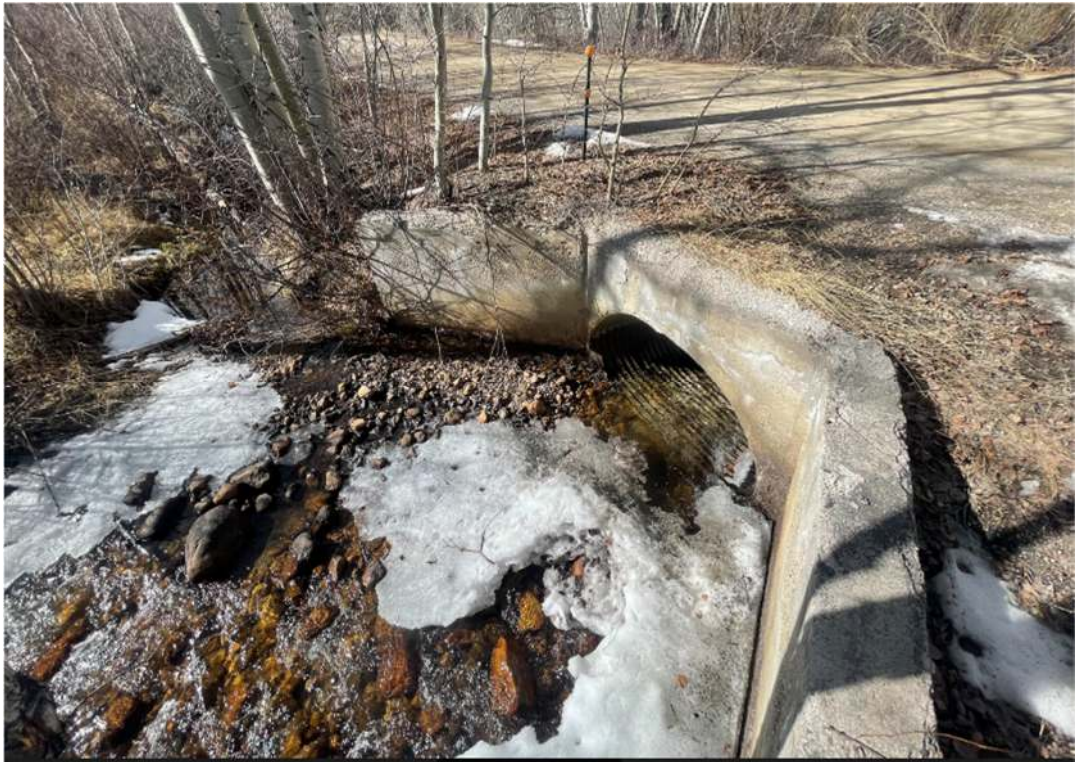
Browns R03

ID	Location		
BC3	Entire reach.		
	Justification		
	Roadways perpendicular to valley are likely to act as dams during a flood when numerous undersized culvert crossings plug. CR 261C (river right (south) side) seems to follow a secondary drainage and may be at times lower than existing Creek bed creating a potential avulsion pathway. Floodfactor modeling has nearly whole valley bottom as wet/vulnerable to flooding.		
Type	Description	Cost	Partners
<p>Infrastructure Retrofits and Upgrades</p> <p>Mitigate Existing Hazards</p>	Conceptual design to address numerous undersized crossings. Evacuation planning and awareness consideration for landowners.	\$\$	Private, County

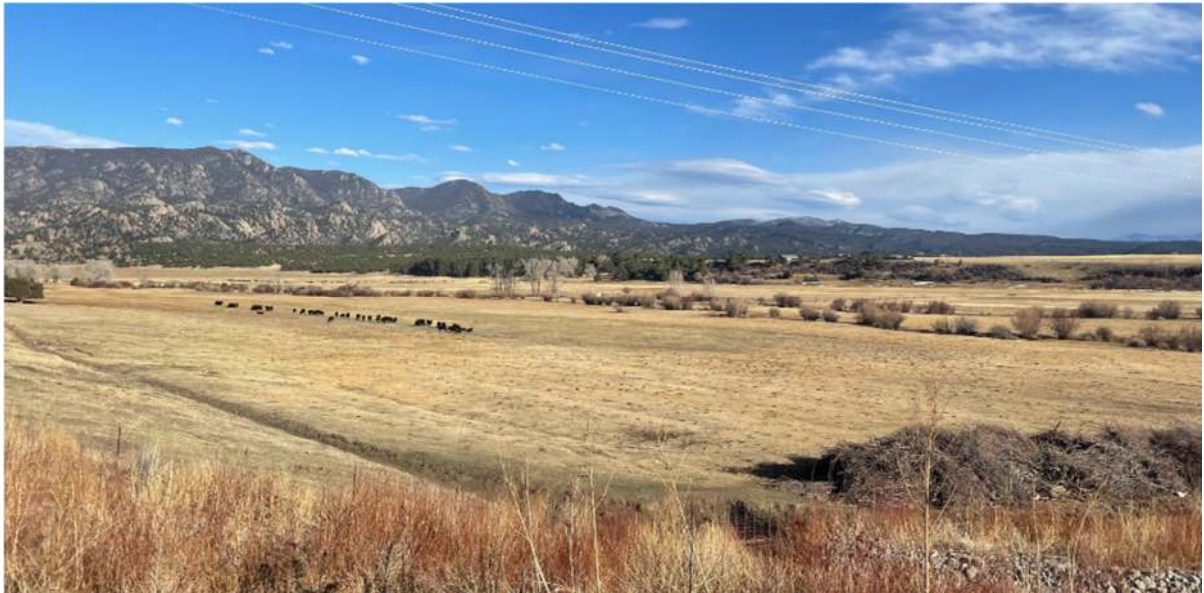
Browns R02

ID	Location		
BC2	Entire reach.		
	Justification		
	Existing open space with compatible land use (ranching). The stream corridor is degraded.		
Type	Description	Cost	Partners
Corridor Rehabilitation, Reconnection, and/or Restoration	Meet with landowners to discuss challenges and opportunities of stream corridor health and protection in this reach. Could be a candidate for PALS and other low-tech improvements (e.g., restore floodplain connectivity and riparian vegetation). Riparian corridor pasture management practices and possible conservation easement(s) could also be discussed.	\$-\$\$\$	Private, NGO

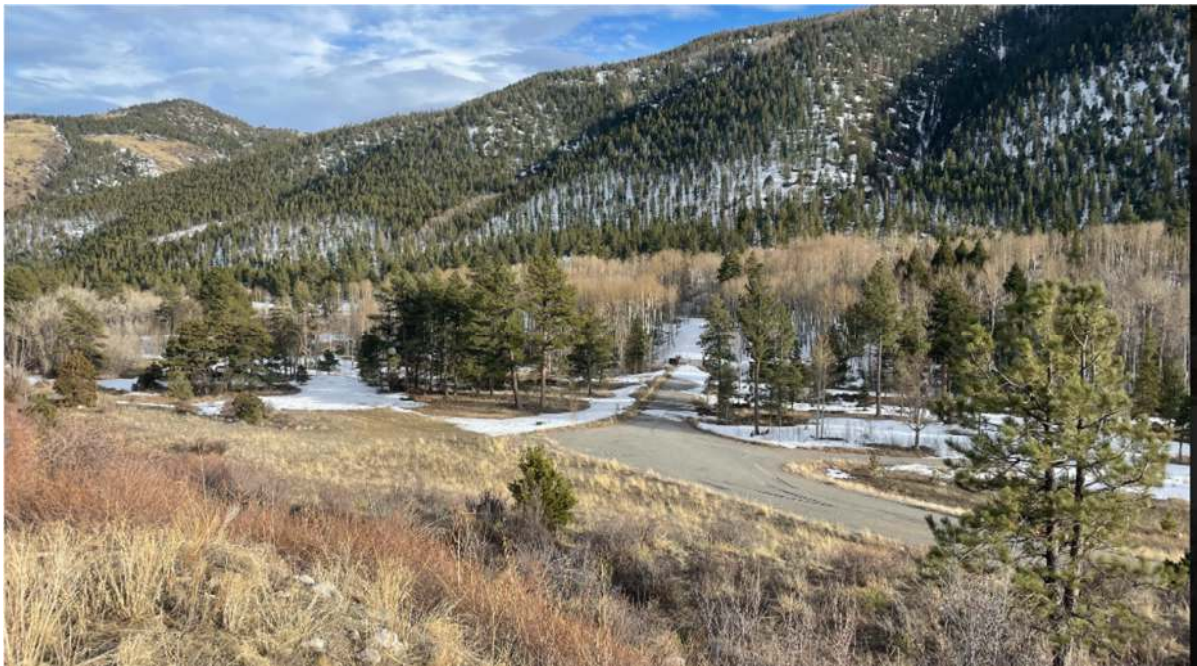
South Ark R04

ID	Location		
SA4	Vicinity of Monarch River Estates		
	Justification		
	Development in Monarch River Estates appears to be vulnerable to future flooding and/or fluvial hazards - especially if watershed conditions change due to a wildfire or in the case of a large flood event.		
Type	Description	Cost	Partners
Mitigate Existing Hazards	Use FloodFactor model and updated CWCB floodplain model to provide guidance to landowners about flood inundation risk.	\$	Private

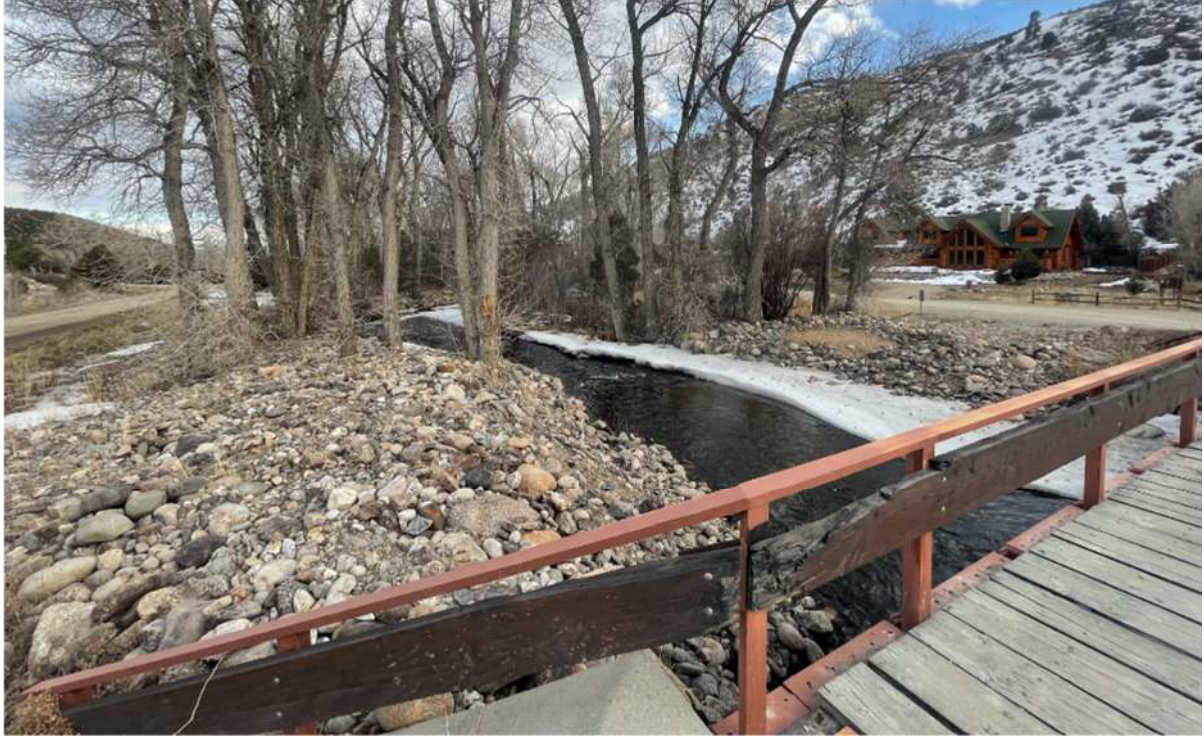
South Ark R03

ID	Location		
SA3a	Maysville		
	Justification		
	Roadways and undersized crossings are preventing the proper transport of sediment and debris. A known issue in Maysville based on observance of excavated channel materials up and downstream of the bridge(s). These structures are likely to cause the channel to avulse during a flood thus threatening nearby existing infrastructure (lives/property).		
Type	Description	Cost	Partners
<p>Infrastructure Retrofits and Upgrades</p> <p>Mitigate Existing Hazards</p>	Flood hazard mitigation study and infrastructure upgrade study. Consider sediment supply from upstream and whether opportunities exist to trap more of it upstream, most likely channel is naturally aggradational here and deposition opportunities should be maintained within reach.	\$\$\$	County, Private

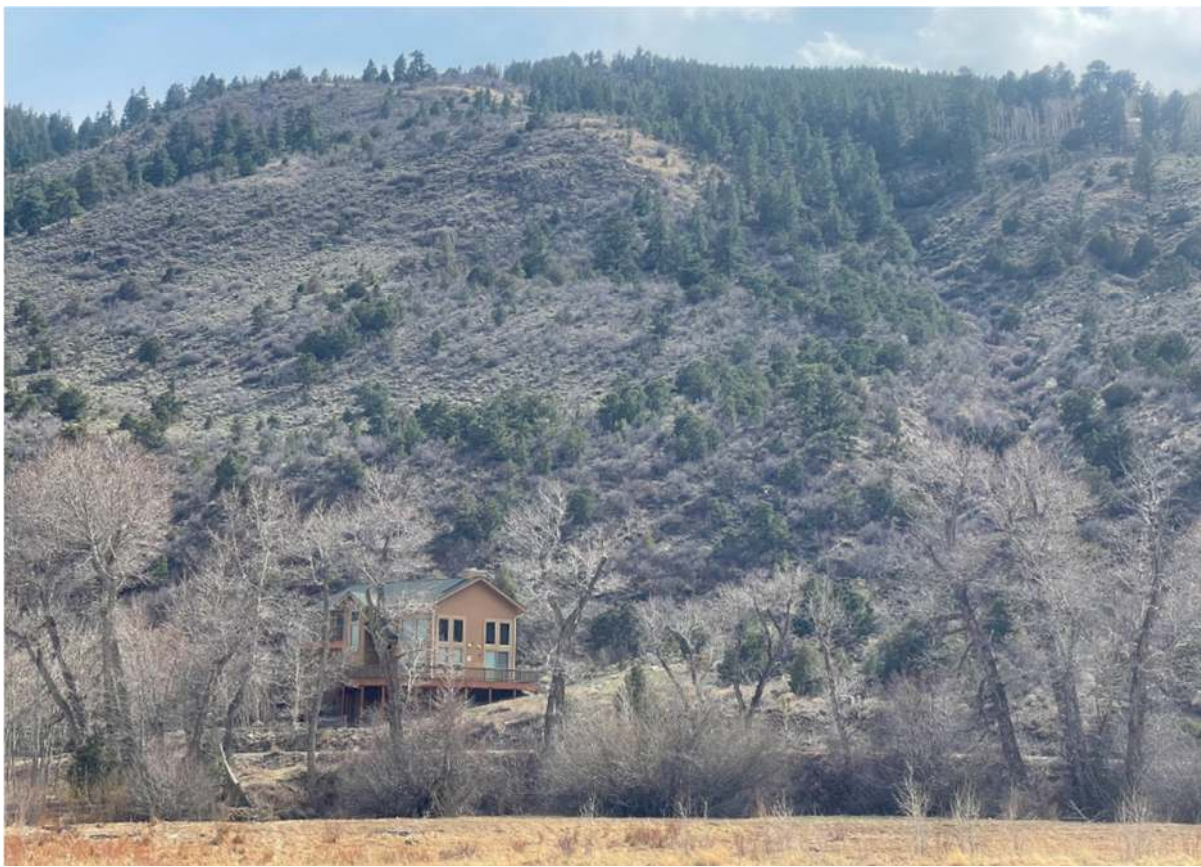
South Ark R03 (cont.)

ID	Location		
SA3b	Maysville		
	Justification		
	Several houses in Maysville are built on debris fans.		
Type	Description	Cost	Partners
Mitigate Existing Hazards	Debris fan mapping and mitigation study for Maysville. Near-term and immediate hazard communication with residents.	\$-\$\$\$\$	Private, County

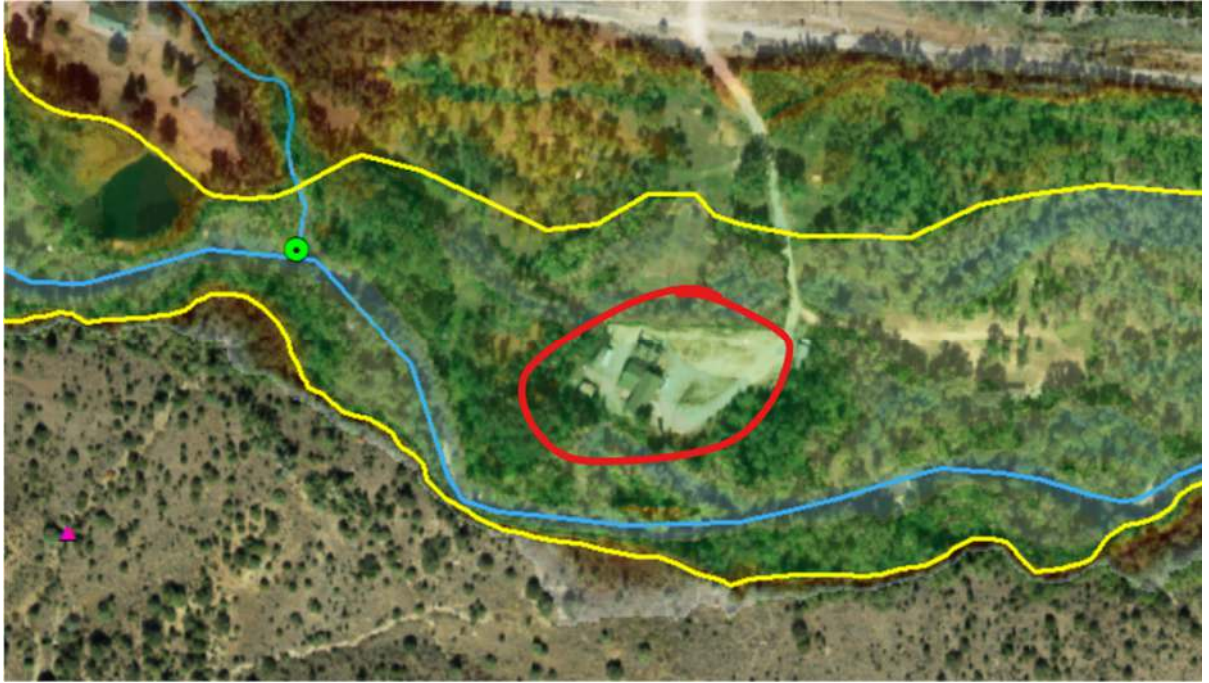
South Ark R02

ID	Location		
SA2a	Vicinity of the confluence of North Fork with the South Arkansas River off CR 220 d/s of Maysville.		
	Justification		
	Electric substation is located in the Active Stream Corridor just downstream of the confluence of the North Fork. May be vulnerable to floods.		
Type	Description	Cost	Partners
Mitigate Existing Hazards	Further investigate the vulnerability of substation and whether mitigation measures can be made. Consider the ramifications of the substation going offline.	\$	State, Feds, County, Private Corp

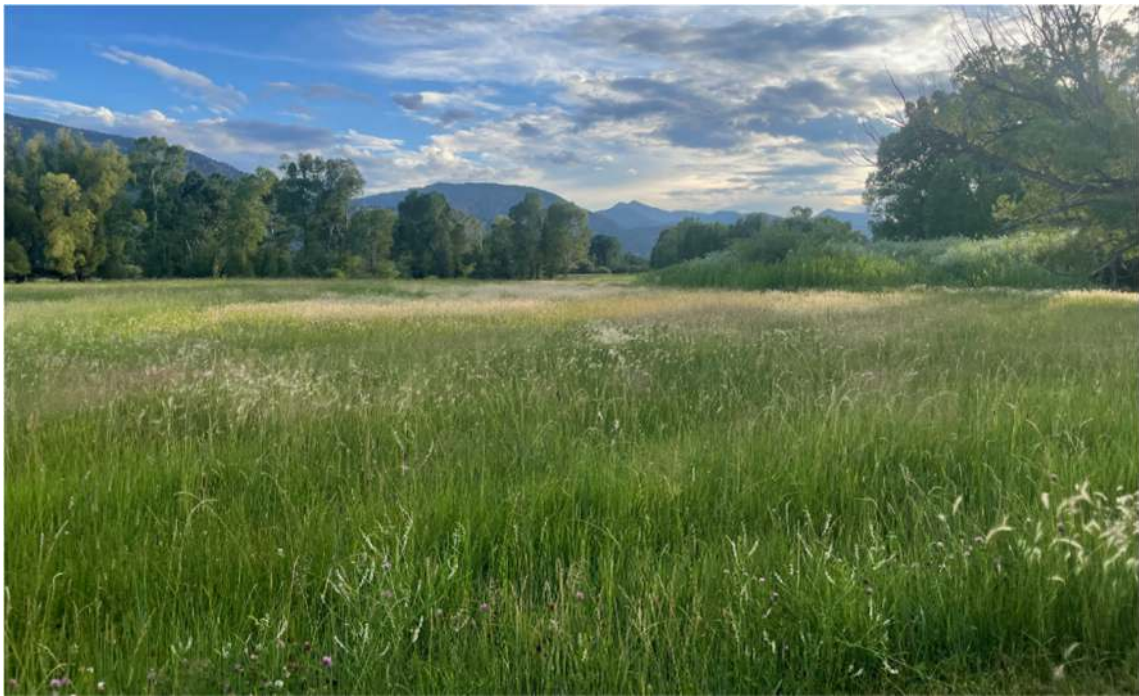
South Ark R02 (cont.)

ID	Location		
SA2b	Entire reach		
	Justification		
	Maintain current open space land use; Restore floodplain connectivity and riparian vegetation (beavers).		
Type	Description	Cost	Partners
Corridor Rehabilitation, Reconnection, and/or Restoration	Meet with landowners to discuss challenges and opportunities of stream corridor health and protection in this reach. Could be a candidate for PALS and other low-tech improvements.	\$-\$\$\$	Private, NGO

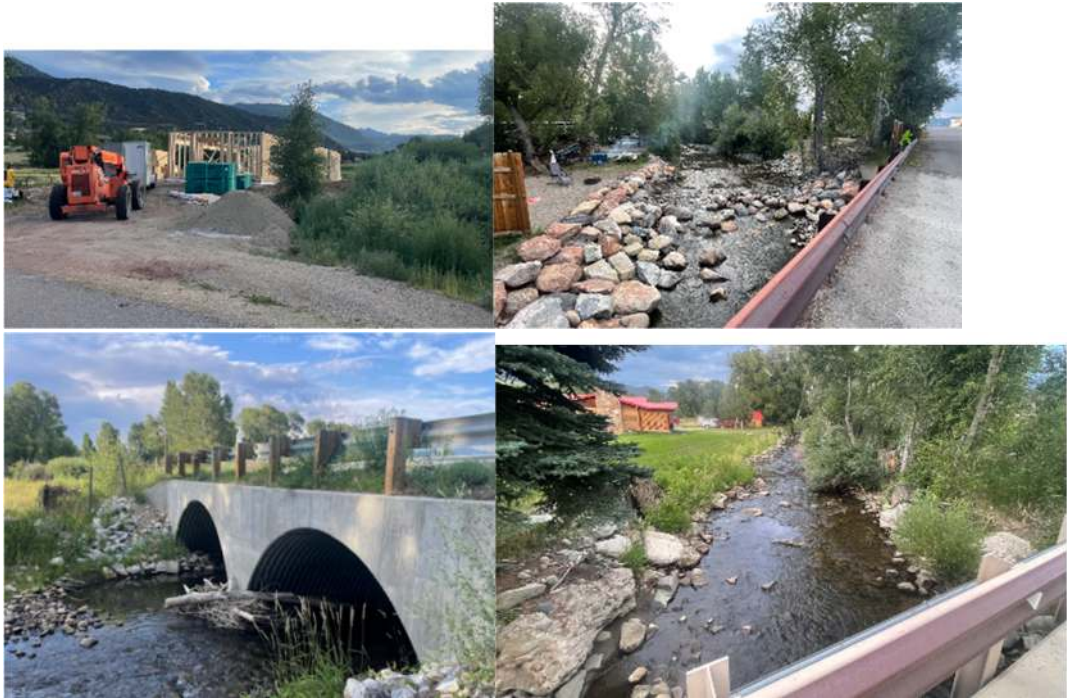
South Ark R01

ID	Location		
SA1	Numerous sites in South Ark 01.		
	Justification		
	Existing development in Active Stream Corridor combined with undersized crossing and elevated road decks threaten life and property.		
Type	Description	Cost	Partners
Mitigate Existing Hazards	Numerous hazards exist here. Simple actions include lowering the road deck at Little River Lane to protect existing houses (provide preferential flow paths for flood waters). More complex actions include infrastructure retrofits, buyouts of non-compatible land use, and infrastructure retrofits. Also, include hazard communication with landowners.	\$-\$\$\$\$	Private, County

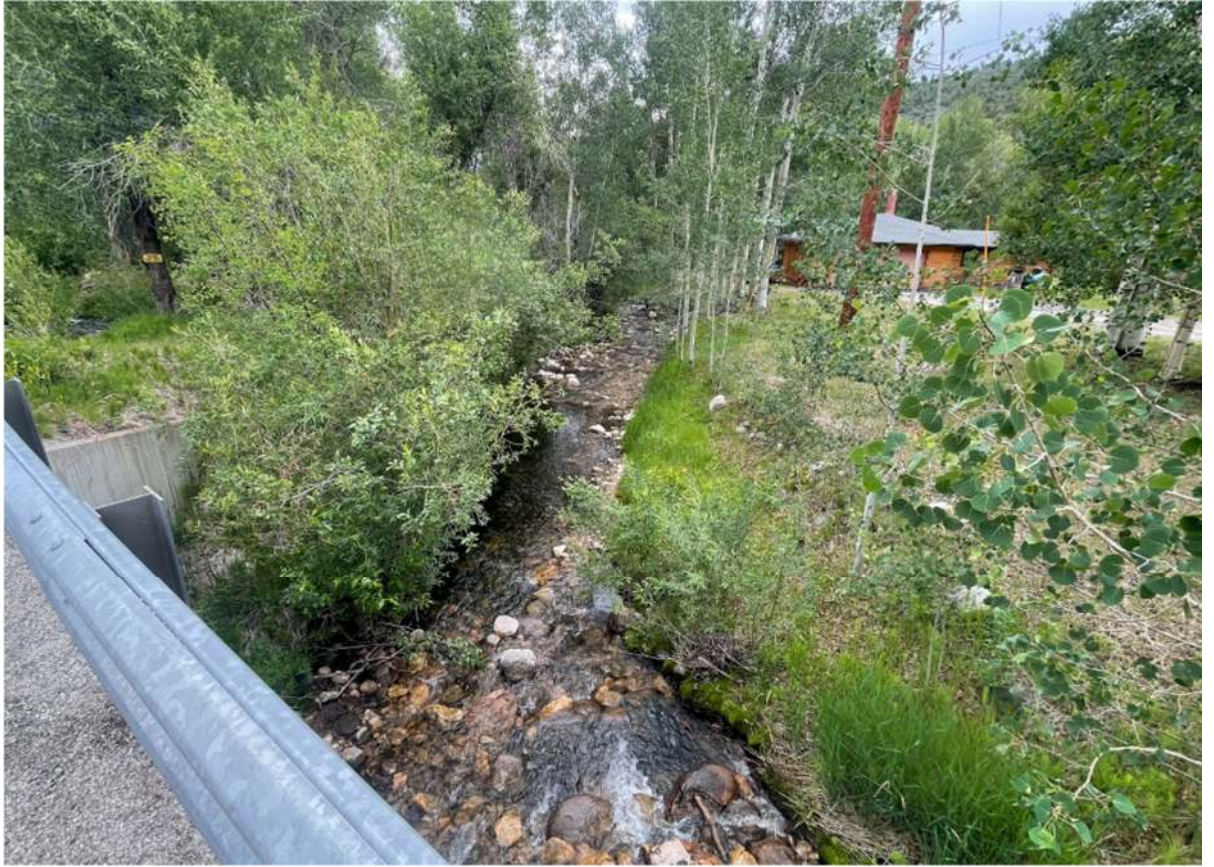
North Fork R01

ID	Location		
NF1a	Entire reach.		
	Justification		
	Development on both sides of the channel in a response reach. The watershed above is mostly forested and vulnerable to wildfire. Not much corridor exists upstream to attenuate sediment and debris.		
Type	Description	Cost	Partners
Mitigate Existing Hazards	Conduct a study to further define the flood, debris flow, and avulsion hazard potential of this area and to identify specific mitigation strategies for these homeowners.	\$\$	County, Private landowner(s)
Infrastructure Retrofits and Upgrades
