Upper Arkansas Watershed Partnership:

Stream Corridor Hazard and Floodplain Connectivity Assessment

Opportunities for Fluvial Hazard Mitigation and Improved Stream Corridor Function

December, 2022

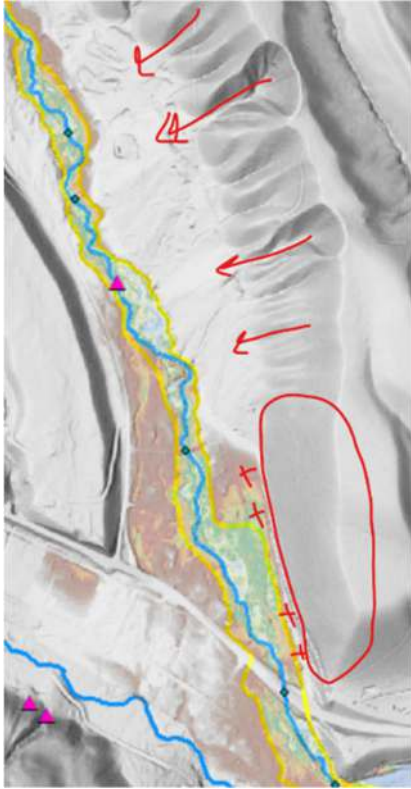
North Fork R01

ID	Location		
NF1b	Lower end of reach, east side of valley above CO 50 crossing.		
	Justification		
	LiDAR indicates hillslope failure potential as does surficial geology map. Houses are constructed in an area that may be susceptible to landslide.		
Type	Description	Cost	Partners
Mitigate Existing Hazards	Contact the Colorado Geologic Survey to determined landslide hazard potential of this area and to identify specific mitigation strategies for these homeowners.	\$	County, Private landowner(s)

<p>Red arrows indicate area upvalley where landsliding has occurred. The southern end of this geologic formation (red circle) has not had these type of failures. Houses exist at the toe of this slope (approximated by red "x").</p>

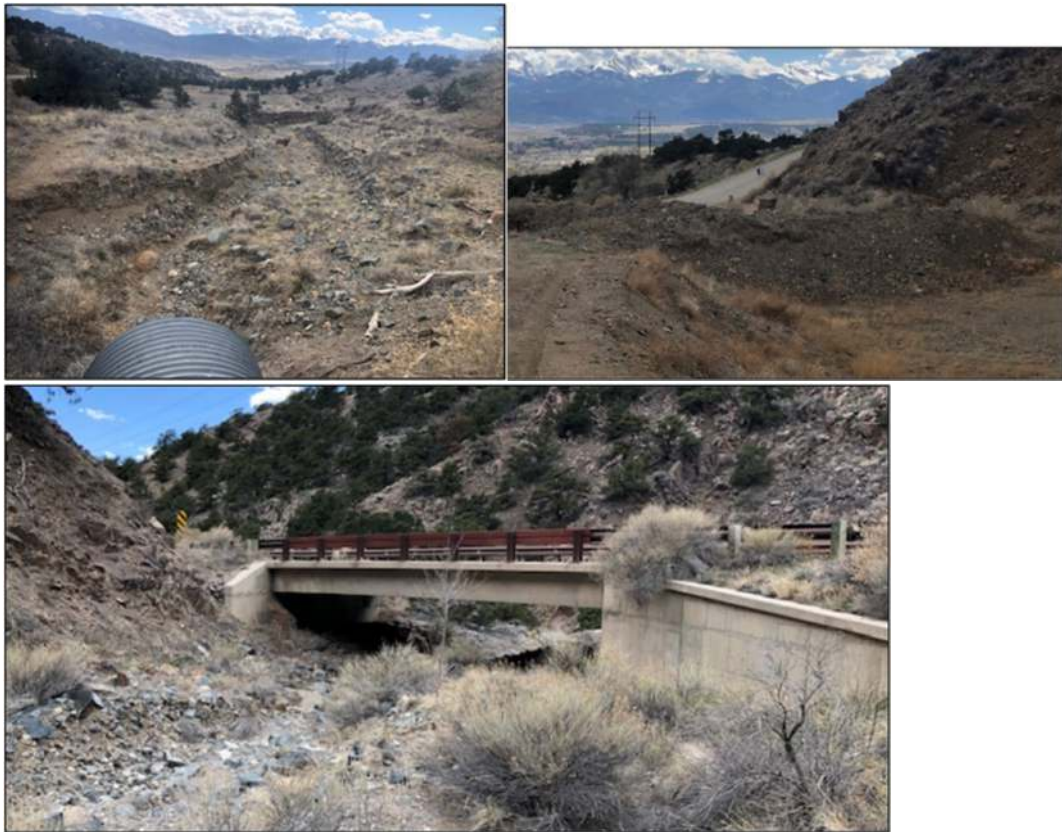
Ute Creek R02

ID	Location		
UC2	CR 156 crossing (top of reach)		
	Justification		
	Significantly undersized crossing along with unpermitted dams and sediment basins create significant avulsion hazard potential as well as increasing threat to development in the Active Stream Corridor downstream of the crossing.		
Type	Description	Cost	Partners
Infrastructure Retrofits and Upgrades	Replace existing “dam” with an appropriately sized bridge (see the photo below of bridge that exists further up the Ute Creek corridor). Restore corridor. Relocate sediments downstream to reconnect the incised channel.	\$\$\$	County

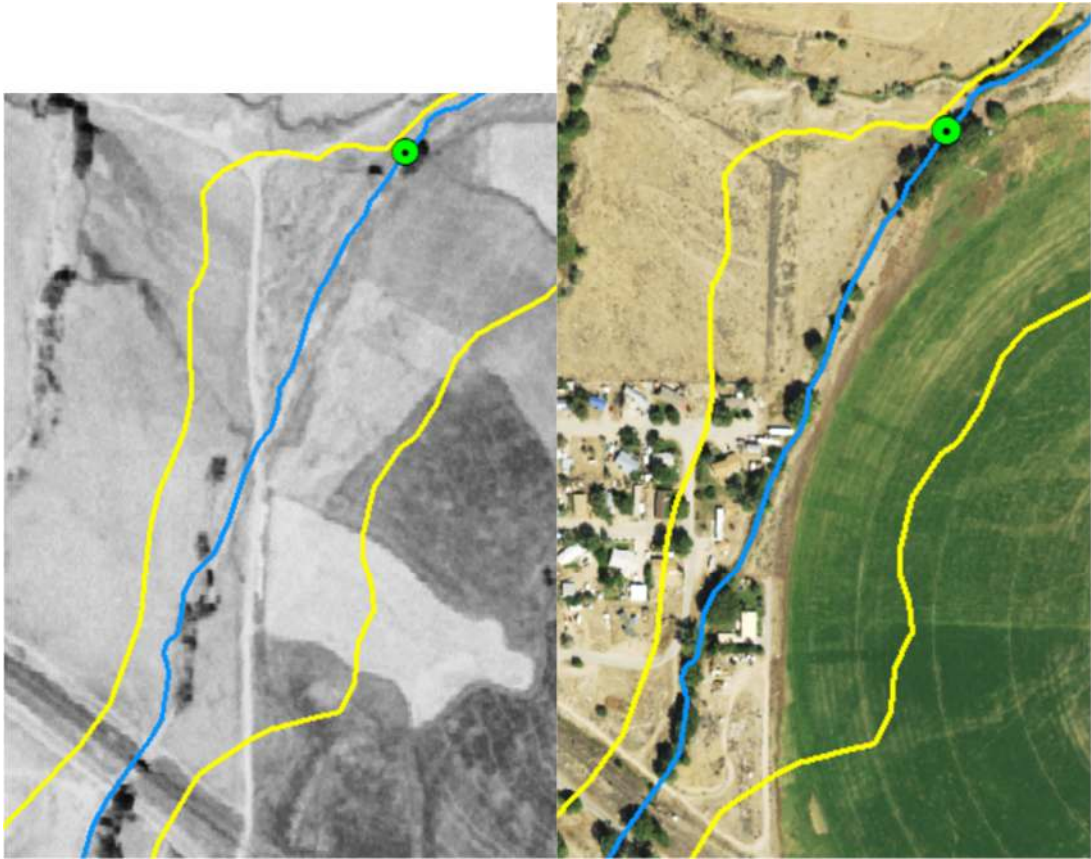
Ute Creek R01

ID	Location		
UC1	CR 156a and 156c vicinity		
	Justification		
	Homes lie in Active Stream Corridor.		
Type	Description	Cost	Partners
Mitigate Existing Hazards	Educational campaign to raise awareness of flood potential in this area and work on evacuation planning. Possible land trade opportunity to relocate some of these structures. At least campaign to get flood insurance for these structures. Consult updated FEMA regulatory maps when they become available in 2023.	\$-\$\$\$\$	County

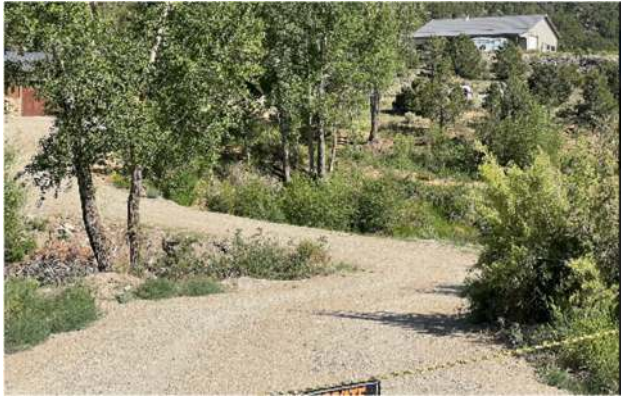
ID	Location		
LC2	Entire reach where crossings/development intersect the fluvial hazard zone.		
	Justification		
	Development on both sides of the channel in source reach. Watershed above is mostly forested and vulnerable to wildfire. Not much corridor exists upstream to attenuate sediment and debris. Recent flooding damaged many crossings.		
Type	Description	Cost	Partners
Infrastructure Retrofits and Upgrades	Provide guidance and assistance to landowners for crossing upgrades.	\$\$	County, Private landowner(s)

undersized crossing and road dam spring '22

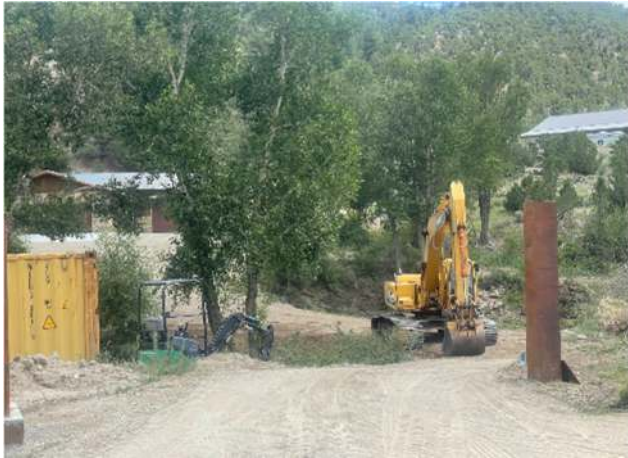
replacing washed out culvert summer '22.

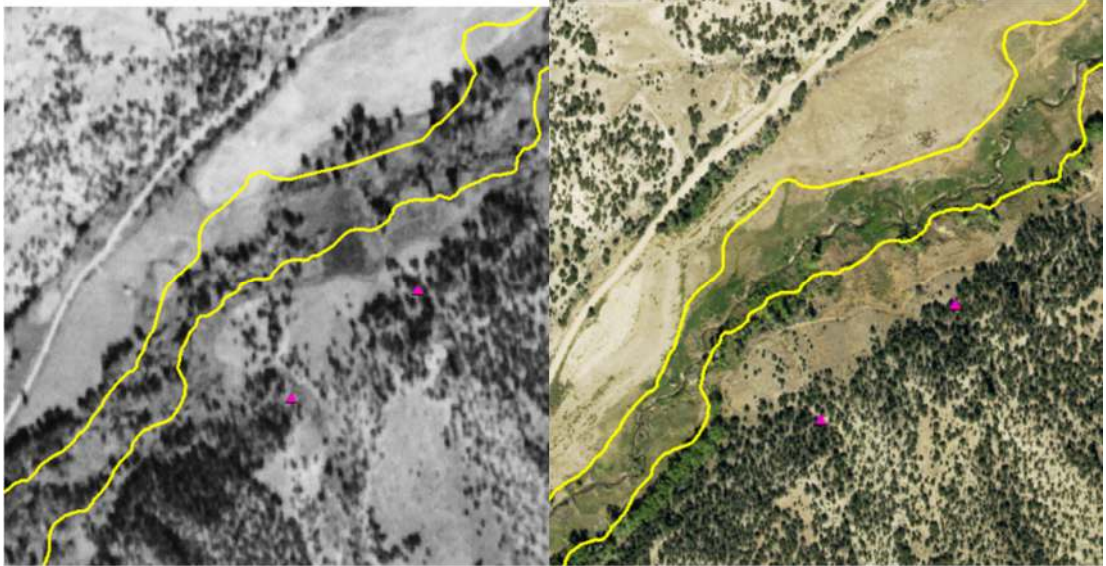
Little Cochetopa R01

ID	Location		
LC1	Near the confluence of L.Cochetopa and S. Arkansas River		
	Justification		
	Steep fire and flood-prone watershed upstream. This is a response reach with an accumulation zone near the confluence with the South Ark (alluvial fan). Floodplain alterations have degraded stream health. Riparian vegetation and beaver dam removal has contributed to channel incision and floodplain disconnection.		
Type	Description	Cost	Partners
Corridor Rehabilitation, Reconnection, and/or Restoration Land and Water Protection	Meet with landowners to discuss challenges and opportunities of stream corridor health and protection in this reach. <i>(Note: It is our understanding that this property was notified of a violation from the ACOE and is currently working with a consultant on a restoration project).</i>	\$-\$\$\$	NGO, Private

<p>Cottonwood trees visible along the creek in 1953 (left) are all but absent in 2019 (right).</p>

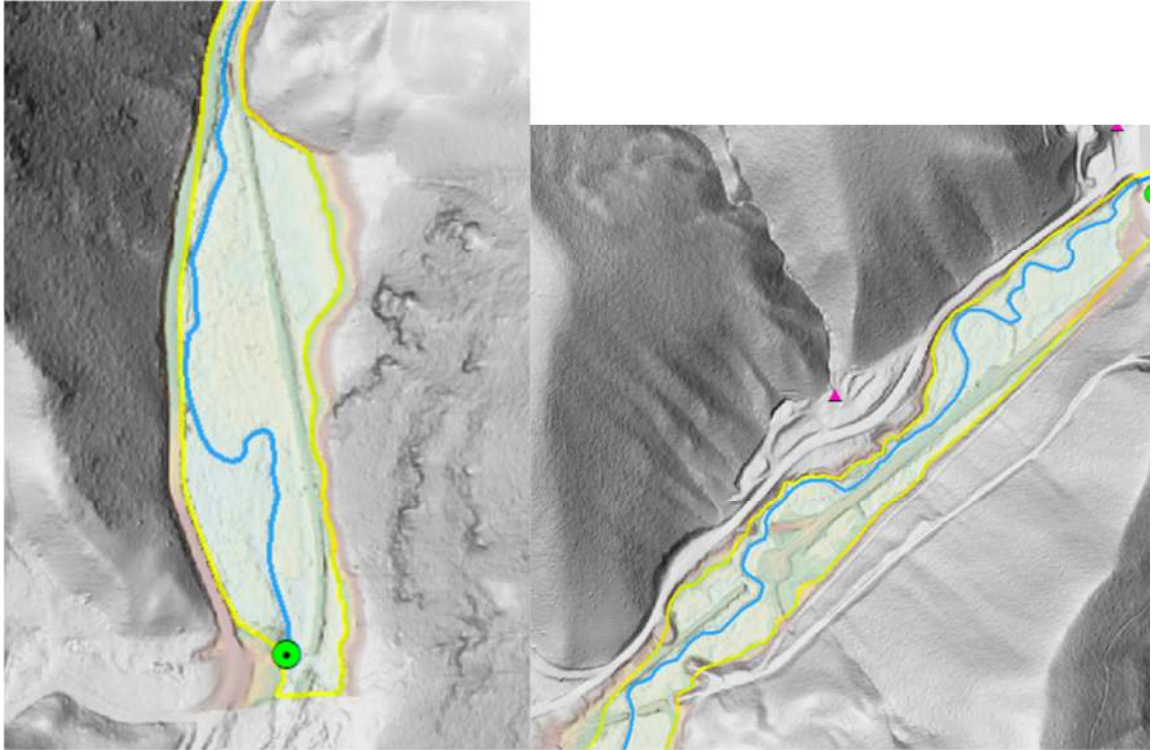
Poncha Creek R03

ID	Location		
PC3a	Entire reach.		
	Justification		
	Unused railbed bifurcates floodplain. Sediment and water storage functions have been reduced and riparian and aquatic habitats are disconnected.		
Type	Description	Cost	Partners
<p>Corridor Rehabilitation, Reconnection, and/or Restoration</p> <p>Land and Water Protection</p>	<p>Reach-scale concept design to identify areas where railbed can be removed and floodplain reconnected.</p>

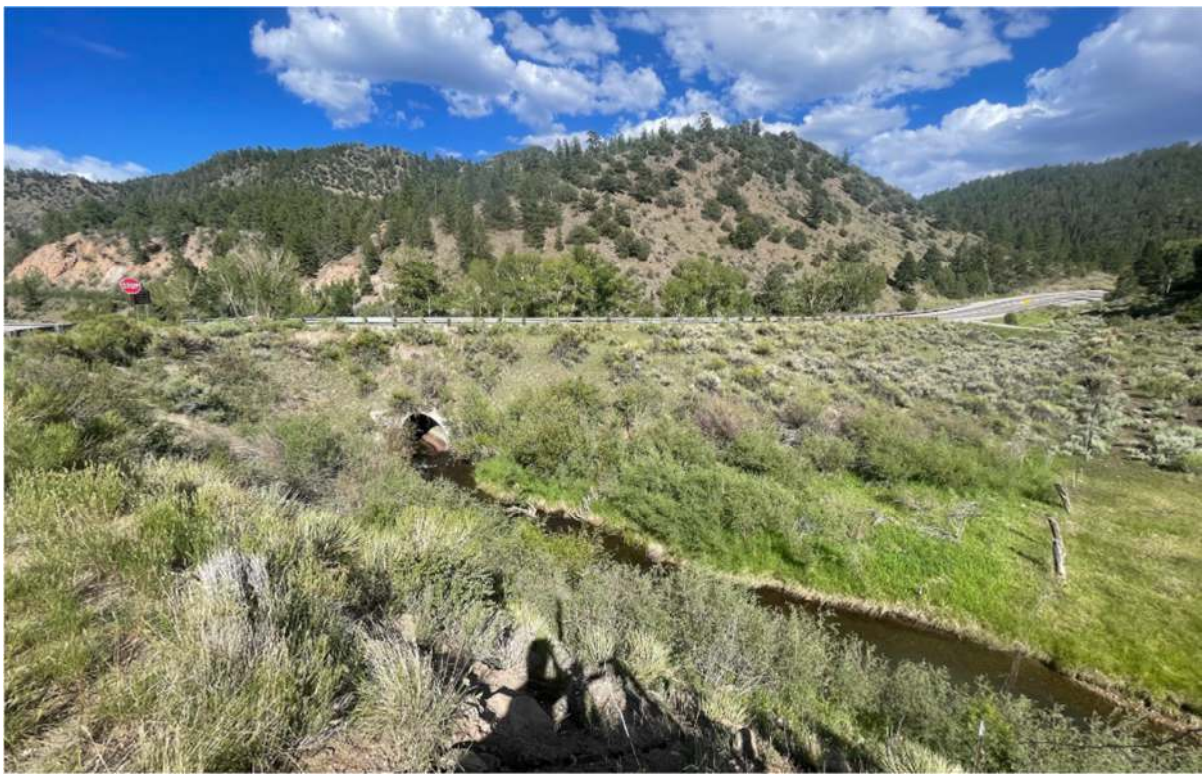
Poncha Creek R03 (cont.)

ID	Location		
PC3b	SH 285 crossing over Poncha Creek near Marshall Pass Road.		
	Justification		
	The culvert under the highway is grossly undersized. Roadway creates a dam that will pond water affecting upstream property owners but more importantly, if it overtops could run down the highway causing much damage.		
Type	Description	Cost	Partners
Infrastructure Retrofits and Upgrades	Design plan for crossing improvement(s).	\$\$\$	CDOT, County

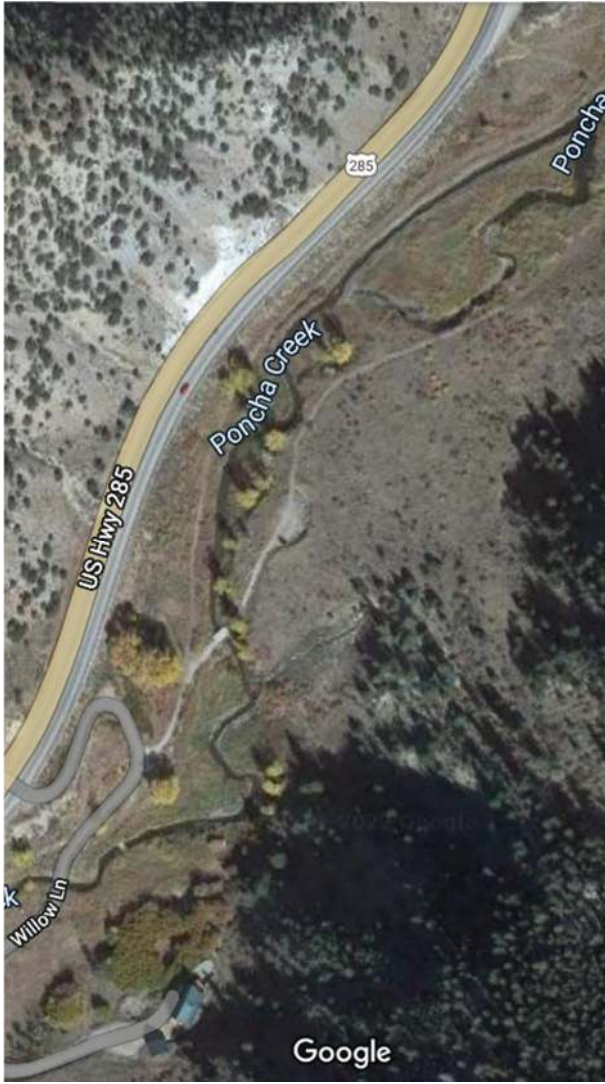
Poncha Creek R02

ID	Location		
PC2a	Near upper end of reach in the vicinity of Willow Lane		
	Justification		
	Significant channel and floodplain alteration. Conversion of response reach to transport reach.		
Type	Description	Cost	Partners
Corridor Rehabilitation, Reconnection, and/or Restoration	Evaluate landowner concerns in this reach and investigate whether opportunities to restore floodplain connection.	\$-\$\$\$	Private, NGO

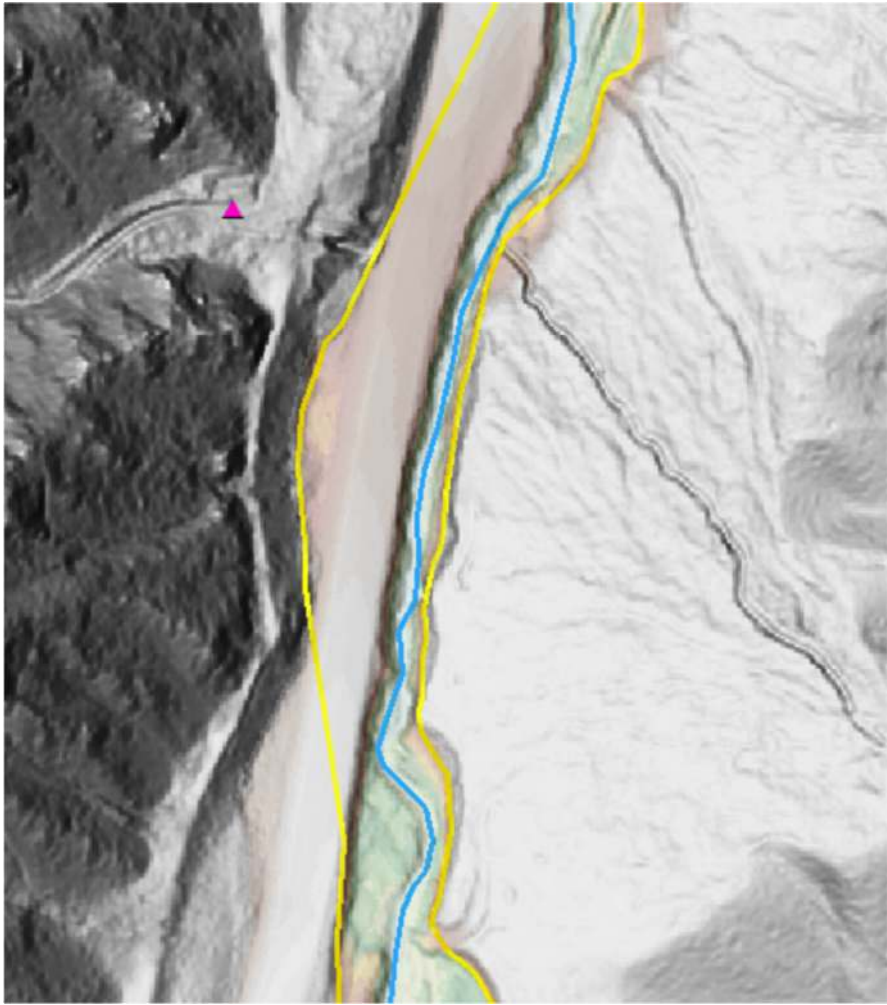
Poncha Creek R02 (cont.)

ID	Location		
PC2b	Entire reach but most specifically where CO 285 contacts that channel and or is placed on fill in the Active Stream Corridor.		
	Justification		
	Highway washout is all but assured in a significant flow event. State/County should be prepared for having this roadway become impassable following a flood event.		
Type	Description	Cost	Partners
Mitigate Existing Hazards	Ensure this topic is discussed in local hazard and emergency planning.	\$	CDOT/County

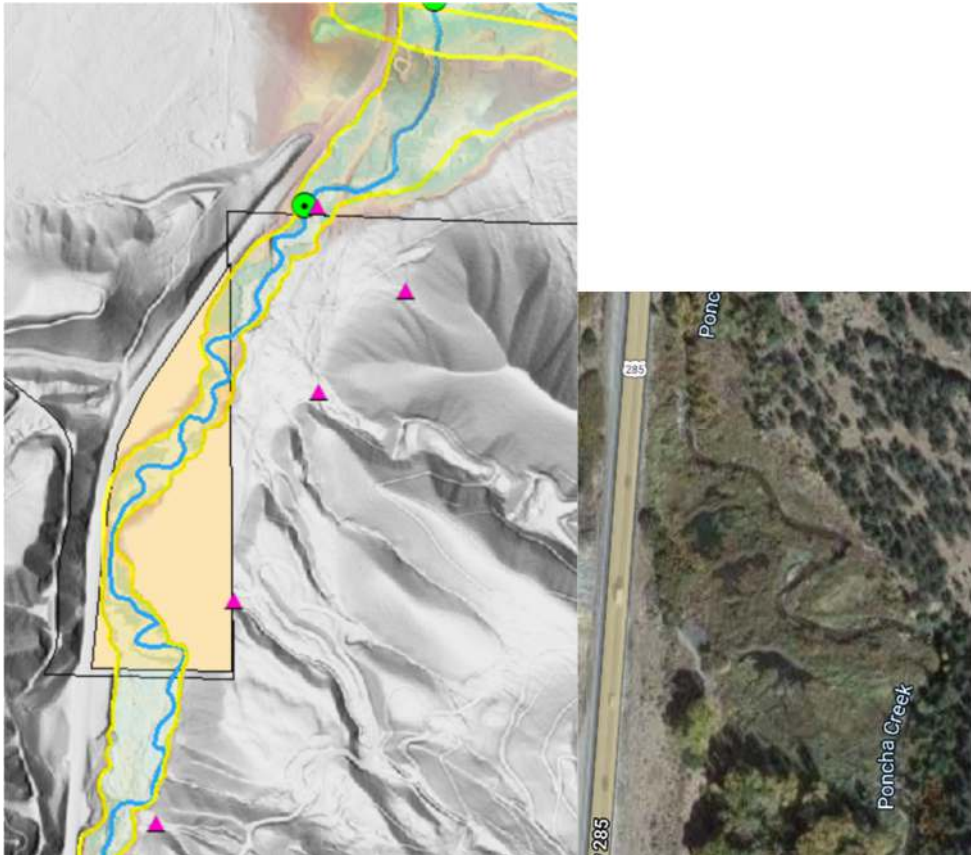
Poncha Creek R02 (cont.)

ID	Location		
PC2c	The lower end of reach in vicinity of Town of Poncha Springs Park		
	Justification		
	Poncha Creek R02 is a steep confined transport reach with numerous debris fans. A large flood will deliver this material directly into the development located at the mouth of the canyon. Small floodplain pockets do exist upstream of this development and may help buffer flood impacts.		
Type	Description	Cost	Partners
<p>Corridor Rehabilitation, Reconnection, and/or Restoration</p> <p>Land and Water Protection</p>	<p>Field investigation to evaluate opportunities to maximize floodplain connection and storage potential to buffer downstream development from flood and debris impacts.</p>

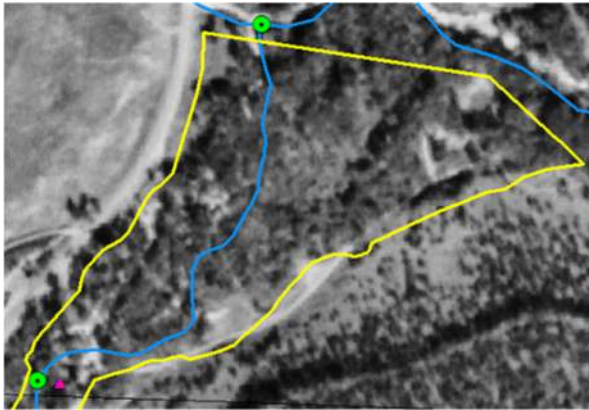
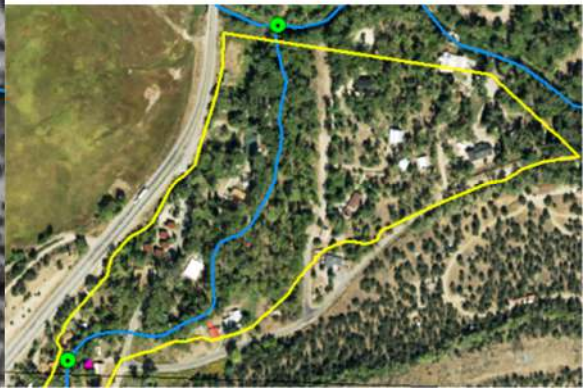
Poncha Creek R01

ID	Location		
PC1	Entire reach.		
	Justification		
	Numerous homes lie in Active Stream Corridor at the mouth of a steep canyon with significant flood and debris loading potential.		
Type	Description	Cost	Partners
Mitigate Existing Hazards	Educational campaign to raise awareness of flood and avulsion potential in this area and develop actionable evacuation plans. Consult updated FEMA regulatory maps but also discuss the likelihood of sediment and debris filling channel(s) and causing water to seek new routes.	\$-\$\$\$\$	County
<div>
